# Sheetpile Bulkhead Collapse

## Hutchinson Island Ferry Landing Savannah, Georgia

Guoming Lin, Ph.D., G.E., D.GE  
Vice President/Senior Consultant

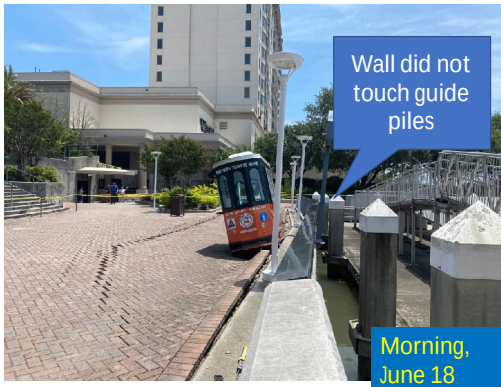
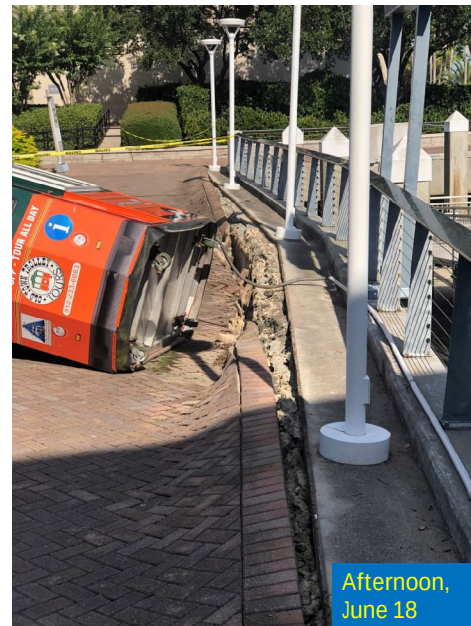
- Morning of June 18, we installed crack meters to monitor the movements;
- By the afternoon of June 18, the bulkhead moved about another foot, damaged the crack meters and toppled the ticket stand.

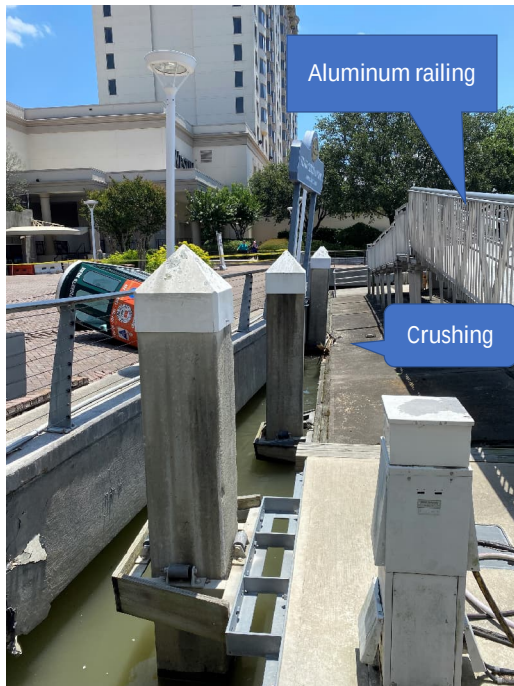
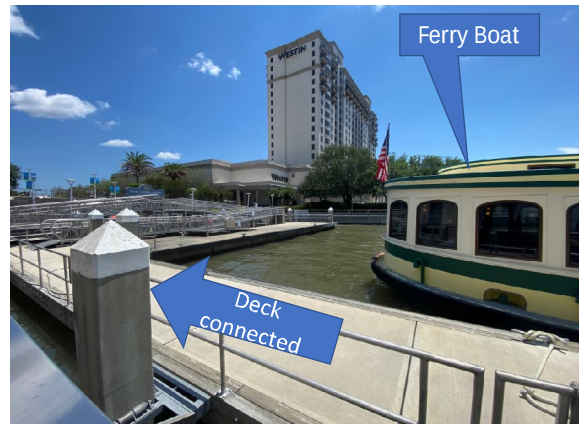
- Next day, June 19, Sunday morning, Westin Hotel contacted me about noisy crushing sounds. The Bulkhead pushed the guide piles that crushed the floating dock;
- I determined that the floating dock was unsafe and ferry services had to stop. The transit authority called a contractor to disconnect the dock and remove the railing.

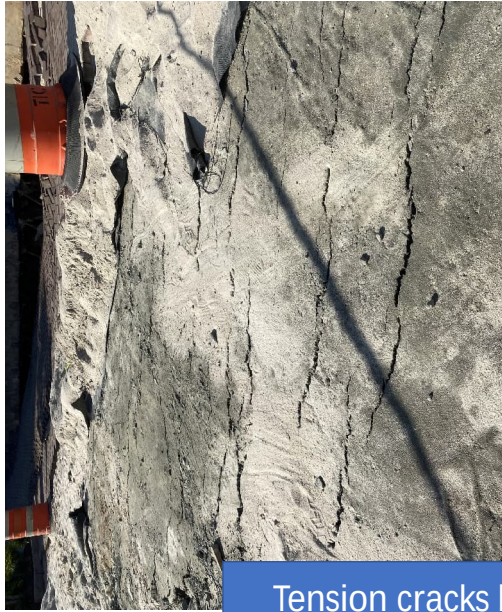
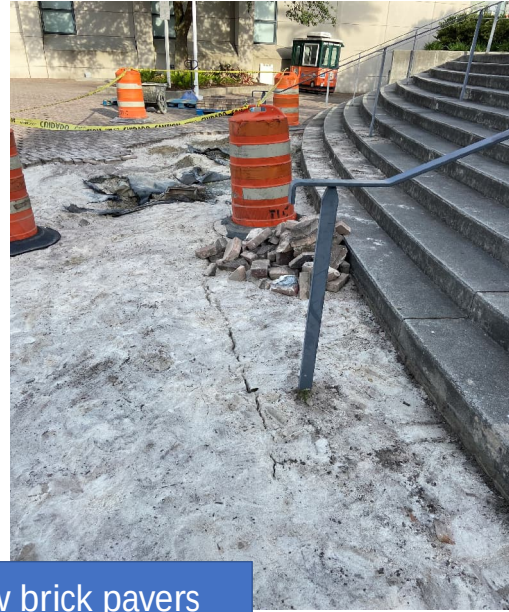
Tension cracks below brick pavers  
To the bottom of the steps

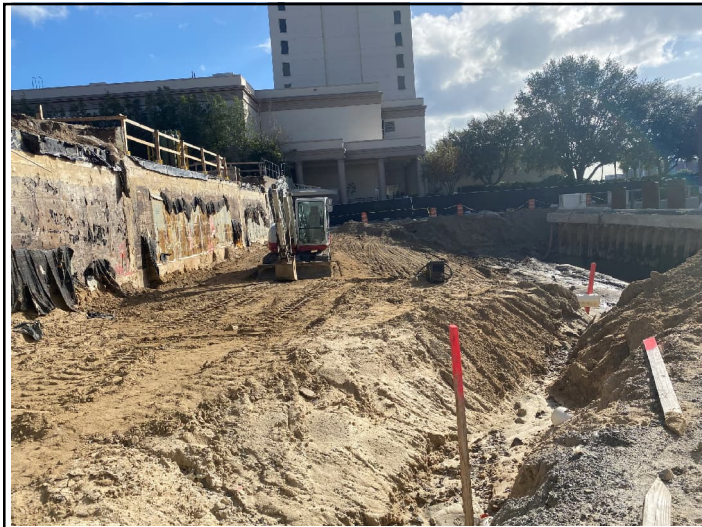
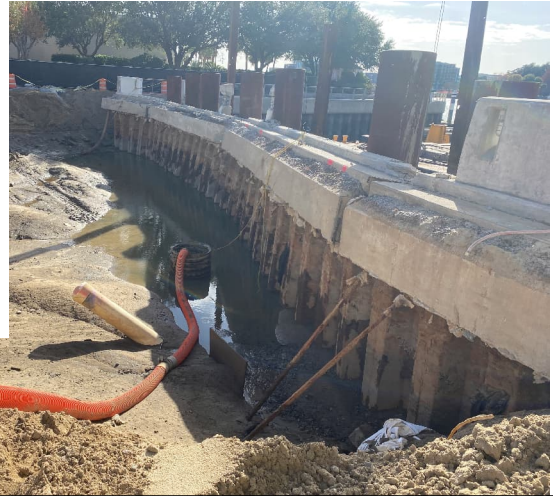
- After the removal of steps and planters
