# Sheetpile Bulkhead Collapse

## Hutchinson Island Ferry Landing Savannah, Georgia

Guoming Lin, Ph.D., G.E., D.GE  
Vice President/Senior Consultant

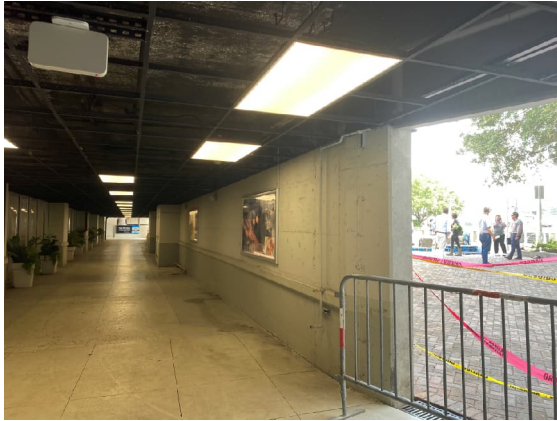
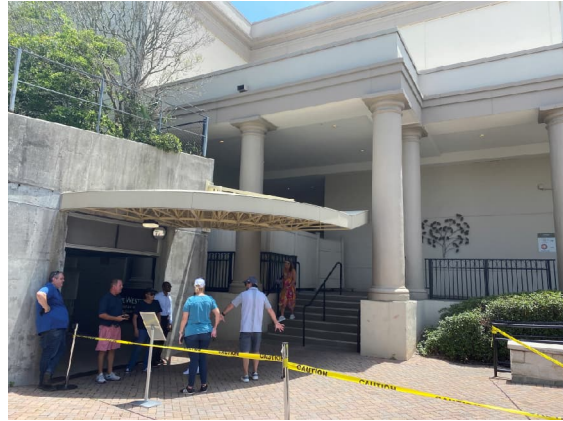
- Is the Savannah Convention Center safe? – Yes.
- Is Westin Hotel safe? – Yes.
- Is the walkway between the Hotel and the Convention Center safe? – not outside, but yes inside.
- Is the Ferry Operation safe? – Was not a question on Saturday, but I became concerned on Sunday (June 19) due to the failing bulkhead pushing the floating dock-Had to be relocated and the floating dock disconnected.

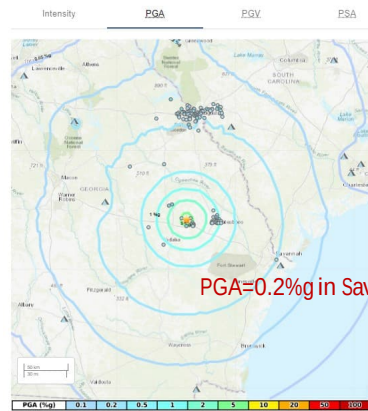
### M 3.9 – 7 km E of Stillmore, Georgia

- M 3.9 Earthquake. 7 km E of Stillmore, about 70 miles west of Hutchinson in Savannah;
- Peak Ground Acceleration (PGA) 0.2%g=0.002g.
- Typical design earthquake (M7.3 centered near Charleston SC) would have a PGA of 0.2g in Savannah.
- This earthquake is about 1% of a design earthquake. Too small to cause significant loads or soil effects like soil liquefaction.
- Seismic monitors on Elba Island LNG did not detect this earthquake.
